Case study

Carlisle Park, Rotherham, South Yorkshire

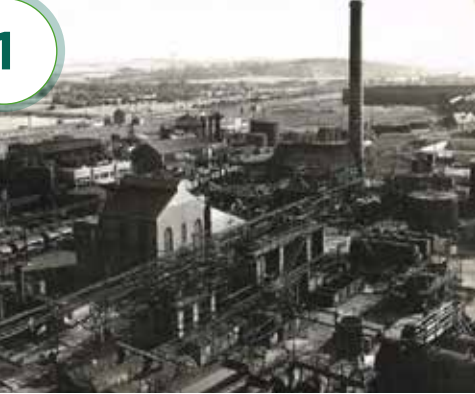
1

100 years of pollution

This site in Kilnhurst, South Yorkshire, had operated as a chemical works for over 100 years.

- It has acted as a bitumen processing plant, tar distillery, iron works and a forge. The site had been derelict for five years before Gleeson acquired it for development in 2012.

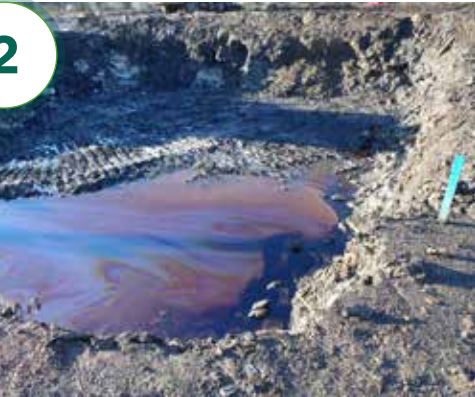
2

Heavily contaminated site

There were three major challenges to the development of the site:

- The land was heavily contaminated with non-aqueous phase liquids (“NAPL”) of petroleum carbons, solvents including phenols, and other less mobile polycyclic aromatic hydrocarbons.
- There were numerous un-surveyed foundations and obstructions from the former chemical works.
- It was unclear what services were passing below the site as the buried services for water, gas and electric were not clearly set out.

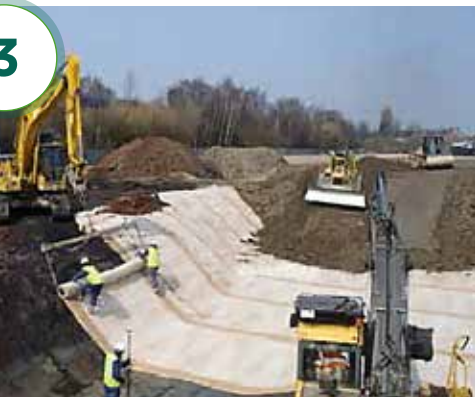
3

£8.6m spent on remediation

Gleeson has spent £8.6m remediating the site over the period of development including:

- 300,000m³ of contaminated ground was excavated, treated and stabilised.
- 25,000m³ of derelict foundation concrete was broken out, crushed, processed and reused.
- A proprietary geosynthetic clay layer, incorporating a bentonite clay layer, was placed over the whole site.
- The site was then capped with a 1.7 meter thick layer of clean material placed as a foundation above the capping layer.

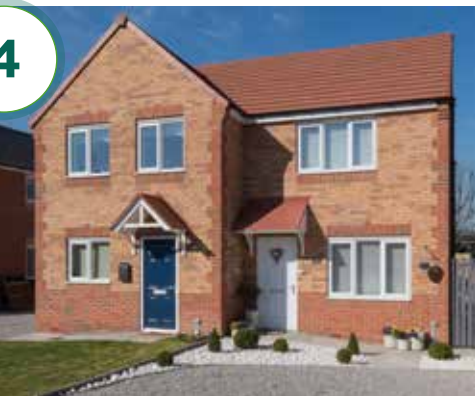
4

High-quality, affordable homes

As a result of the remediation we:

- Cleaned the site.
- Stabilised the contamination.
- Reused all the stabilised materials on site.
- Exported and recycled for scrap the waste metals from the structure of the chemical works.
